Manhole Inspection Summary

Manhole # S29KK_045MH

Insp Date: **7/10/07 9:01 AM**

Location Address: **1833 BOLTON ST**

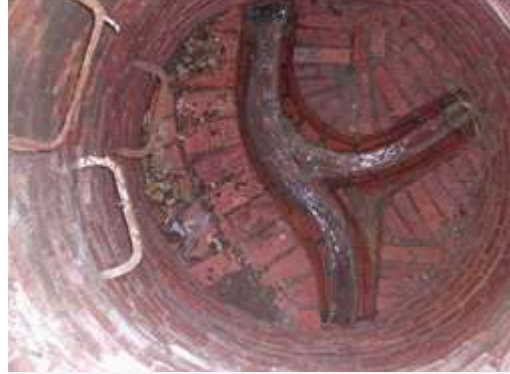
Top View

Corroded steps. Bench debris.

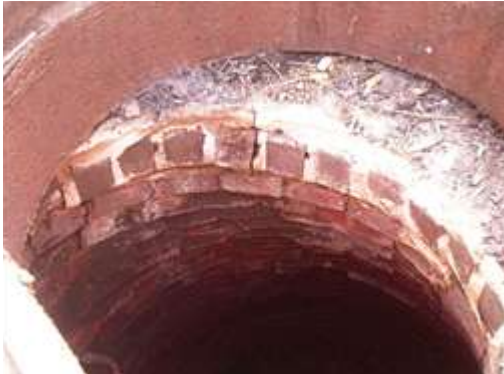
Defect

Frame leaks. Frame offset. Adjustment deterioration and infiltration. Corbel infiltration - other side.

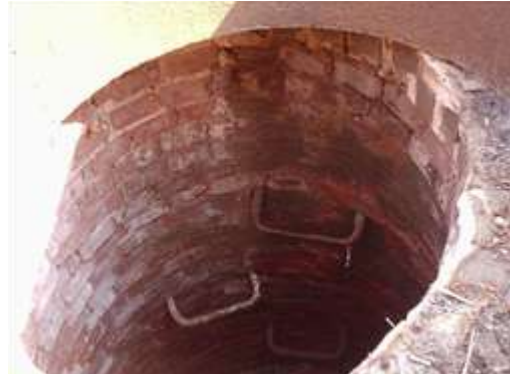
Defect

Frame leaks. Frame offset. Adjustment deterioration and infiltration. Corbel infiltration.

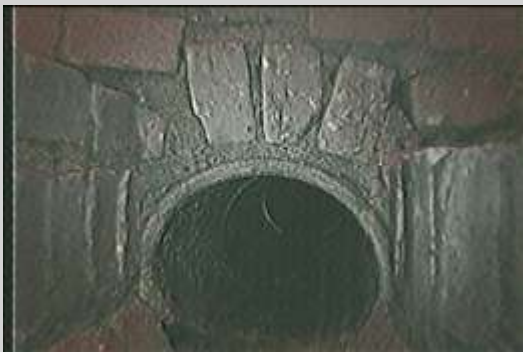
8 in. Circular Gravity Sewer Pipe Out @ 12 O'Clock

Deposits: ☒ None ☐ Mud ☐ Sludge ☐ Debris ☐ Grease

Infiltration: **None** Pipe Seal Cond: **Unknown**

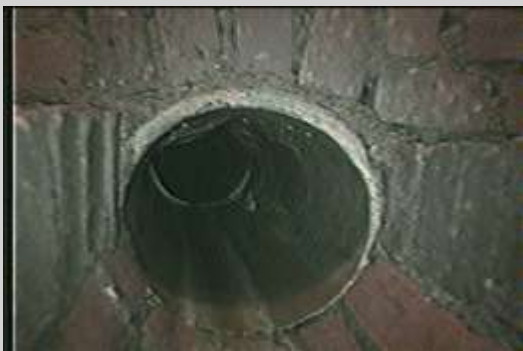
8 in. Circular Gravity Sewer Pipe In @ 3 O'Clock

Deposits: ☒ None ☐ Mud ☐ Sludge ☐ Debris ☐ Grease

Infiltration: **None** Pipe Seal Cond: **Unknown**

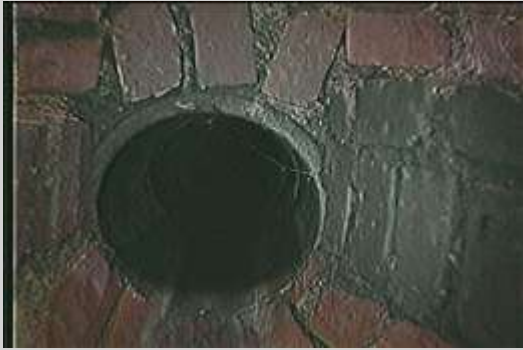
Pipe In @ 6 O'Clock

Deposits: ☒ None ☐ Mud ☐ Sludge ☐ Debris ☐ Grease

Infiltration: **None**
